**ENVIRONMENTAL IMPACT ASSESSMENT REPORT FOR  
PROPOSED RESIDENTIAL SUBDIVISION  
AT KULUKULU, NADROGA**

The Institute of Applied Sciences, USP

Nature Consultants of Fiji

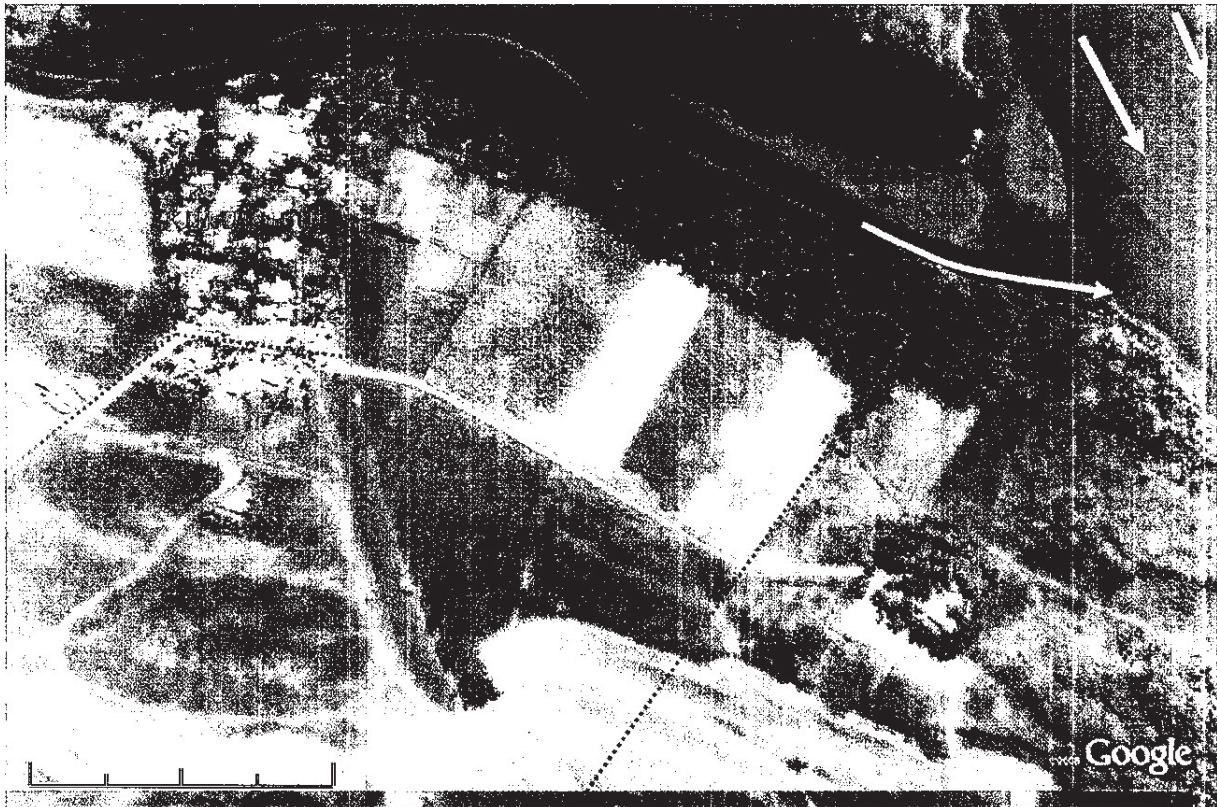
Figure 2 (a): The project site

Beginning from the top, the Vatueta Creek runs from west to east and re-joins the Sigatoka River as shown by the arrow. The Sigatoka River flows along the northeast corner. There is an area of tree vegetated area along the river bank. The project site looks to be very flat but the topographic map will show the elevations well which also pronounce the geology of the site. It is

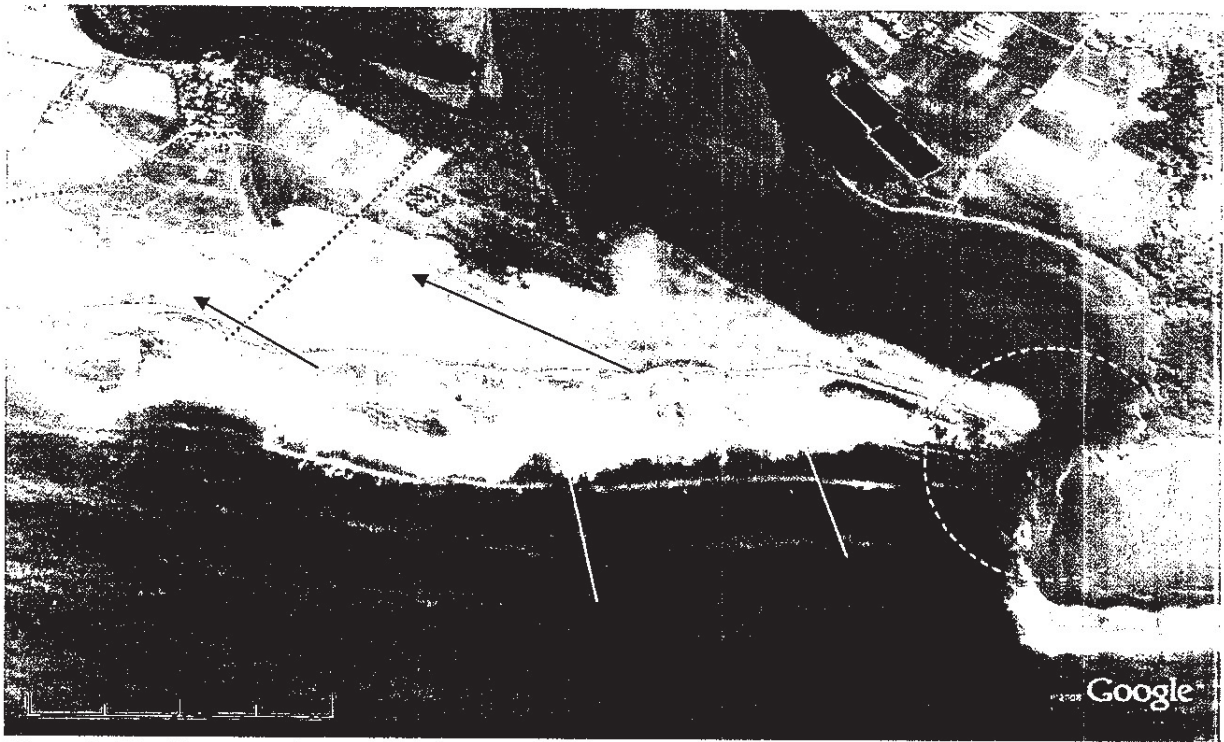
Figure2 (b): Close up views of the project site, its coastal, parallel waves, east sand dunes and the bottled-neck river mouth

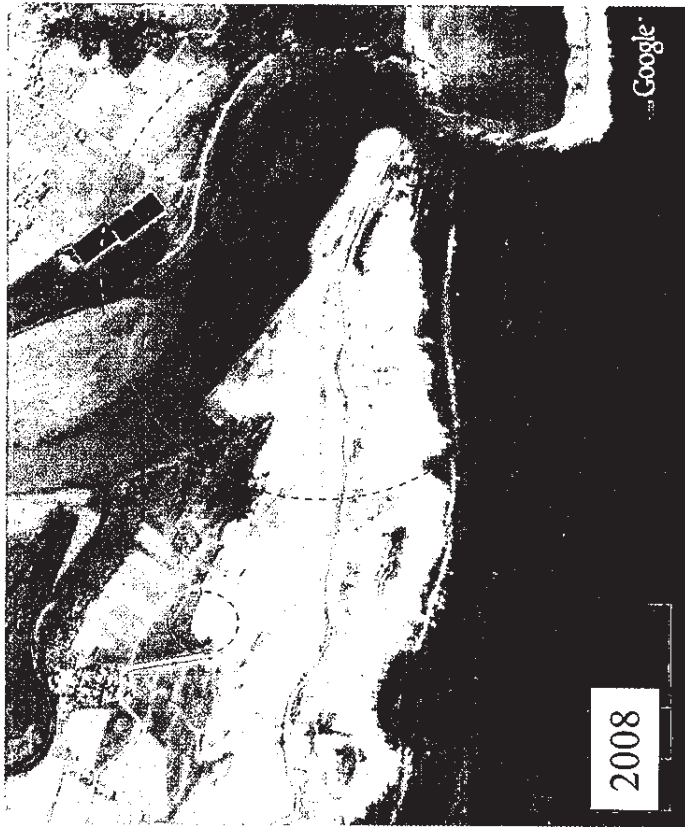
Aerial views of the site looking back through time. It is unfortunate that overlays to fully appreciate the rate of changes can not be calculated because the images are of different map scales. However, there are obviously significant changes distinctly shown in the last 22 years.

- Sigatoka River is shallower in 2008 compared to 1994 and 1986
- Channel bar build-up along east bank of river
- Changes in the mouth bar is controlled by tidal system
- 1994 the elongated mouth bar was that is seen in 1986 was totally destroyed and moved about within the mouth.
- That could have been caused by Cyclone Kina in around March 1993 which caused flooding in the Central and Western Divisions
- In 2008, mouth bar has changed form again and sign of new deposition at mouth
- Sand dune has migrated much closer to the track (red) in 22 years
- The shoreline has also changed to a cusped form in 2008

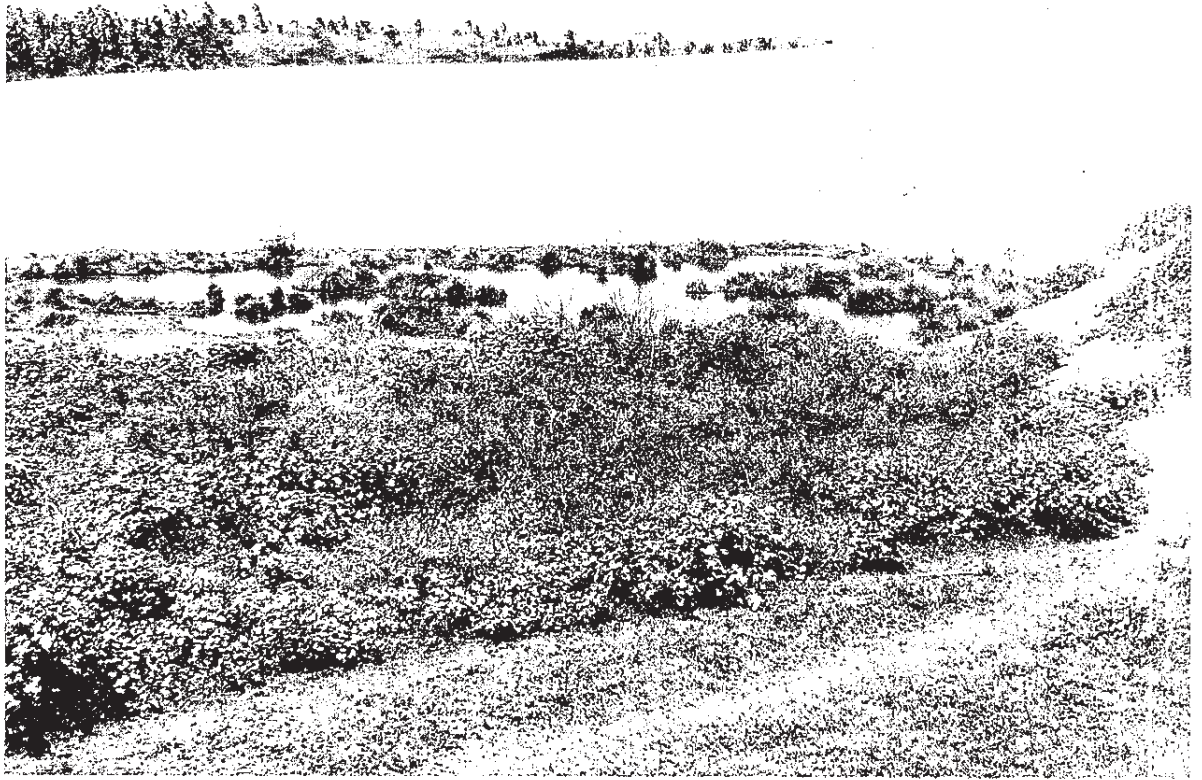
Figure 15: A pool of water by the sand dune probably filled in during the last rainfall. The head of the dune that is migrating westward is behind the pool of water.

It is very important to observe the attitude of the dunal system. The elevation is seen in Figure 16 above and the head is seen in Figure 15. There are a series of four dune systems visible in Figure 16 and they are all within the site. All the elevations are showing some positive signs of stabilising as indicated by the ground vegetations that grows along the sides of the dunes. All dune systems are elongated in the direction of movement which is linear towards the west. While the outer dune is stabilising as can be seen above the inner dune part is active in the migration process causing a hollow within, as the sand moves forwards as seen in insert 2 above.
