**FINAL MONITORING OF ENVIRONMENTAL  
IMPACTS OF DREDGING  
AT DENARAU**

**INSTITUTE OF APPLIED SCIENCES  
THE UNIVERSITY OF THE SOUTH PACIFIC**  
**JUNE 1998**

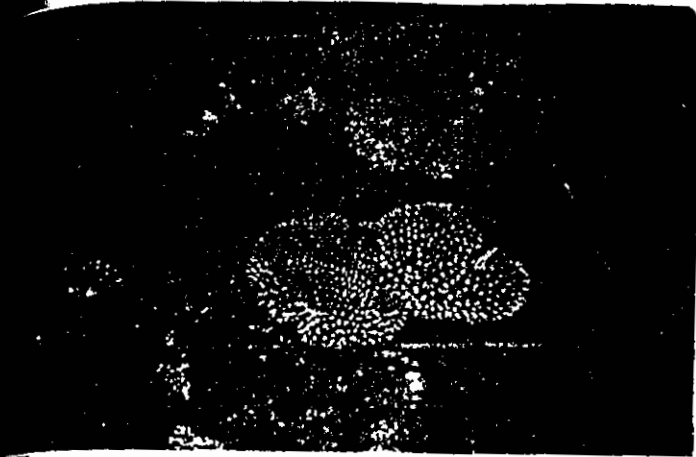
- a) Quadrat 1: Established and photographed in December 7, 1991, this quadrat reflects the *Acropora* dominated growth that characterises the Alacrity and Yakuilau sites.
- b) Quadrat 1: July 14, 1992, the coral assemblage has been reduced with three large colonies of *Acropora* missing from the previous photo. As this is a shallower site, wave action would have a prominent effect. It is likely that this is the result of anchor damage as tourists frequent this area because of the cay and its protected anchorage. Prior to the flood it was a attractive snorkeling location.
- c) Quadrat 1: October 14, 1993, the coral assemblage has been altered with the mortality

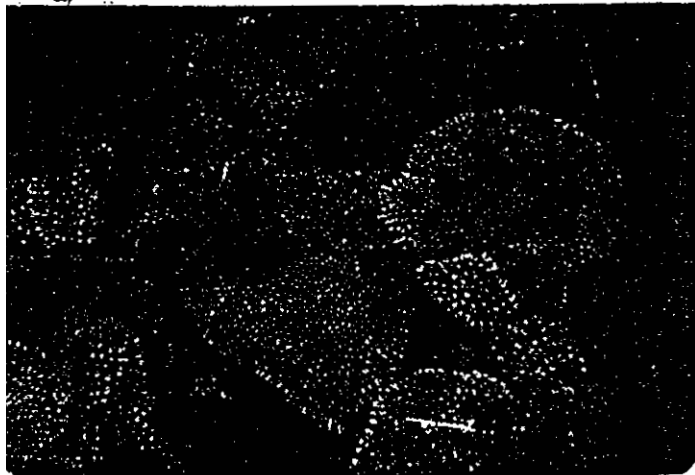
-d): YAKUILAU REEF: SITE 4

(Figure 4 2.4 a-d)
