Environmental Monitoring - Denarau Marina Development

IAS ENVIRONMENTAL STUDIES REPORT NUMBER: 70

April, 1994

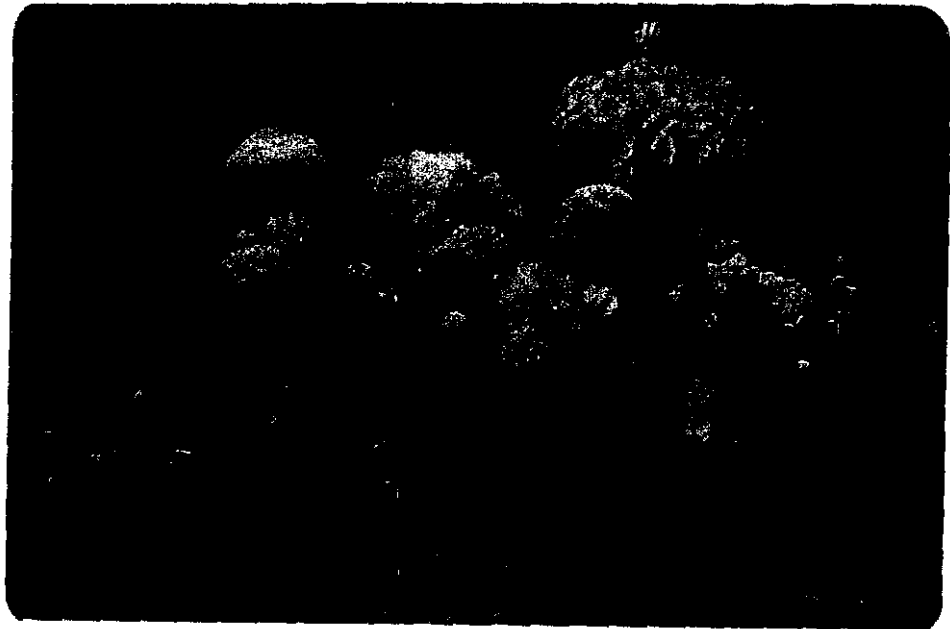
Photo 5: Malan Cay: Site; quadrat 3
July, 1992

Quadrat 3: Mortality occurred in the *Acropora selago* recruits, observed in the second visit. The rest of the colonies appeared healthy.

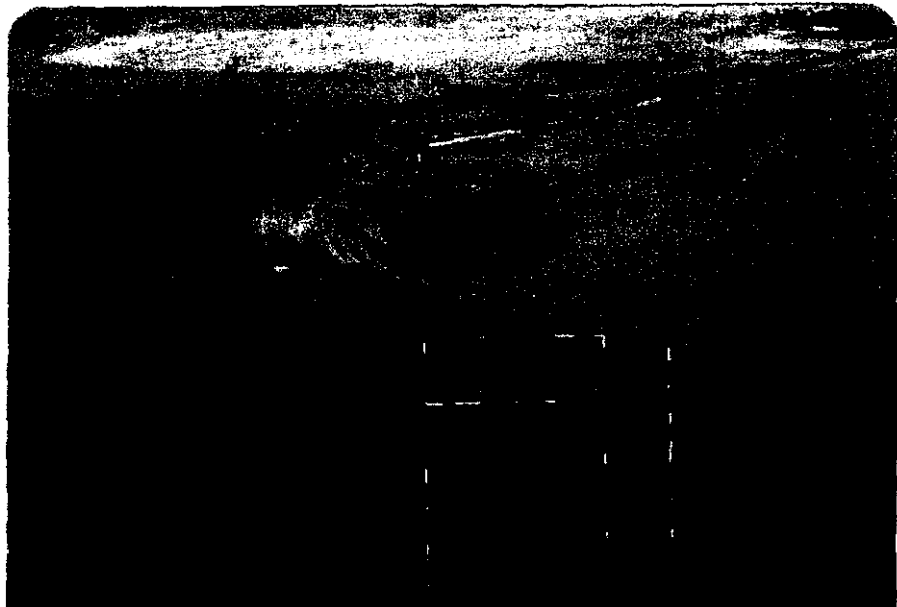
Photo 26:

The success of the dykes in containing the plume is evident in this photograph (lower half of the photograph), and the consulting engineers responsible for this aspect of the development should be commended.
